Dell-Cisco Spanning Tree Interoperability Testing and Recommendations

Victor Lama
Fabric Specialist – G500
April 2011

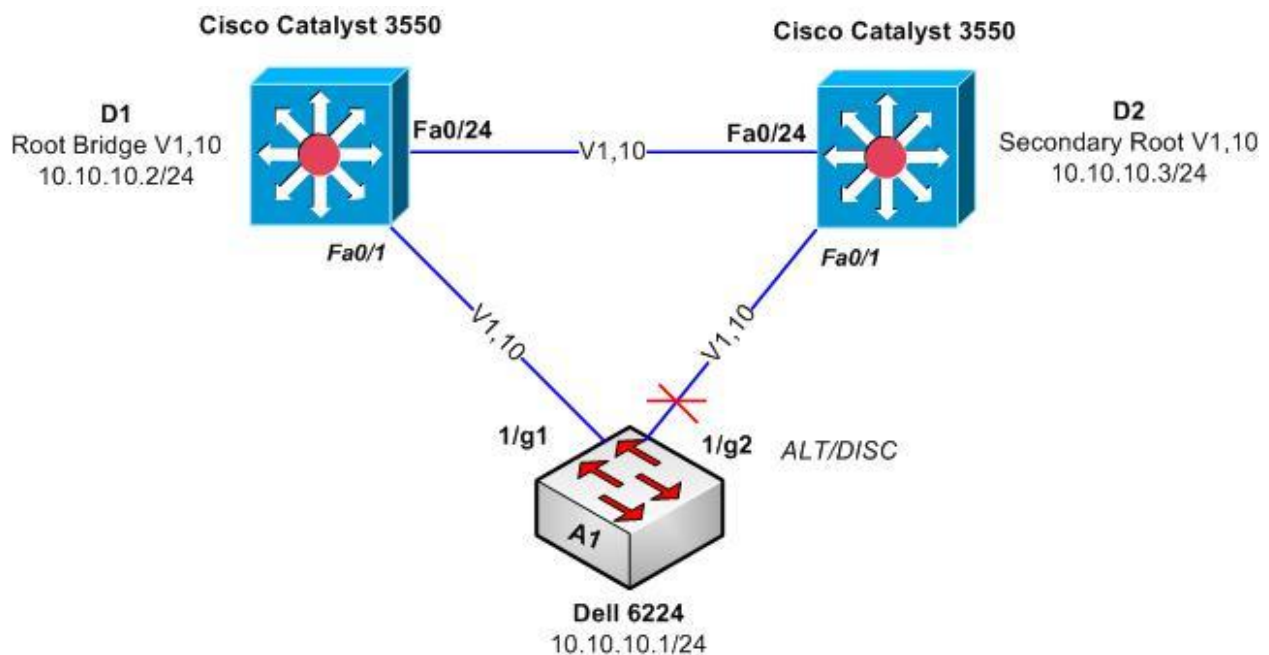
- 2 Cisco 3550 switches at the distribution layer (D1 and D2)
- 1 Dell Power Connect 6224 switch as the access switch (A1)
- 3 Category 6 UTP Cables

Figure 1 - Lab Design. Looped Topology

The next few examples show the detailed configurations of the Cisco D1 and D2 switches, as well as the Dell 6224 A1 access switch. The configurations are followed by a series of 'show' commands to illustrate the state of Spanning-Tree convergence prior to testing. Pertinent notes are in *blue italics*.
